Heavy Duty Diesel Dampers Do Wear Out

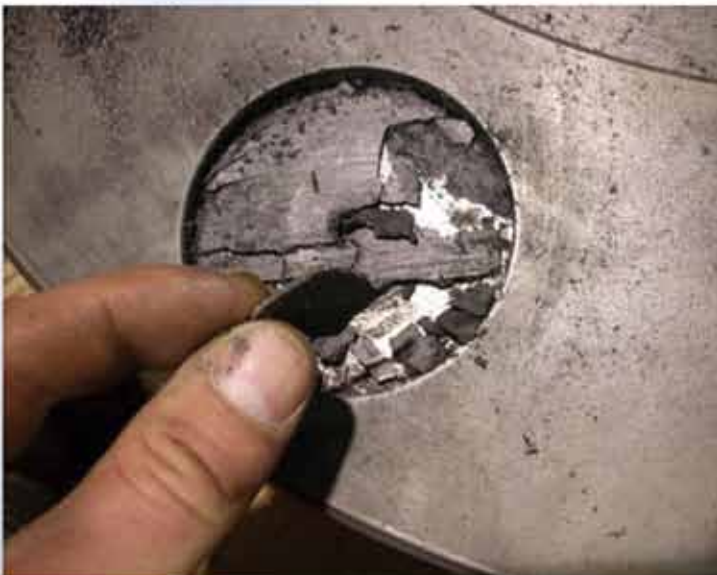
Worn-out viscous damper showing dried silicone flakes. Silicone should be clean and fluid.

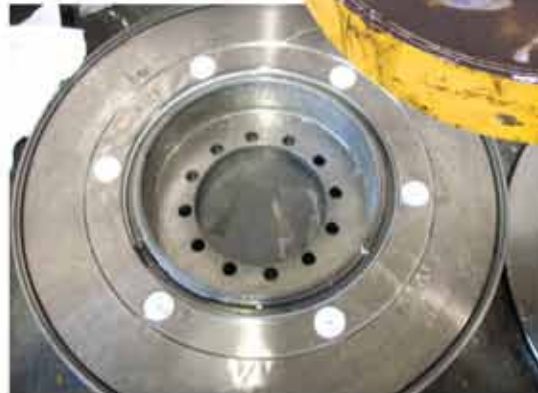
Picture shows a damper with silicone that is still clear and fluid.

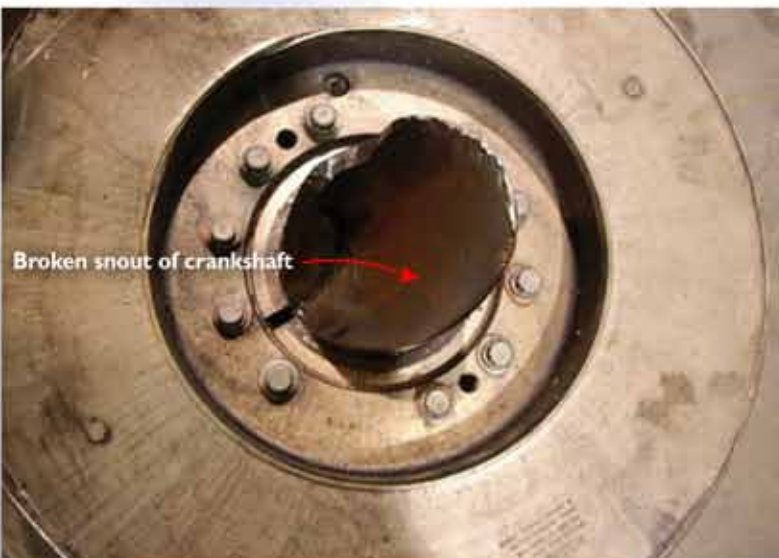
This damper came from an engine that had been rebuilt but the damper was not replaced. The end result was a broken crank (picture top right). The deteriorated condition of this damper was clearly a major factor in the failure of the crankshaft.

Broken snout of crankshaft

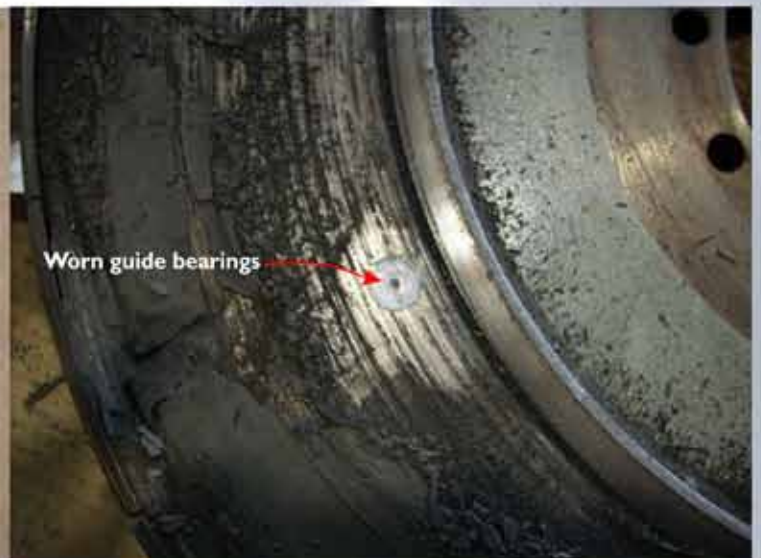
Worn guide bearings
